Applied Surface Technology, Inc

Protective Coatings at Work

Client: Smithsonian American Indian Museum, Washington, D.C.

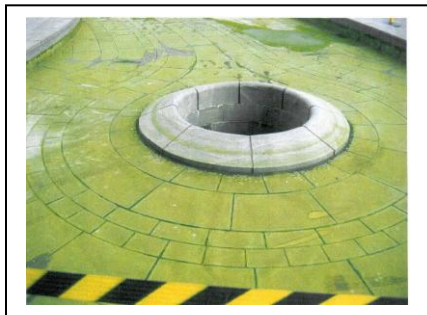
Problem: The hot and dry summer of 2005 took its toll on the outdoor “Indian River” at the Smithsonian, Washington D.C. Algae and bacteria began to grow and multiply in this slow-moving water exhibit. After failed attempts at cleaning the granite, Applied Surface Technology was called to recommend a solution.

Before

Solution: The algae, bacteria, and calcium deposits on the granite stones were completely cleaned and coated with our unique Microguard® protective coating. Our coating products are unique in that they are completely inorganic, non-yellowing, and extremely durable. Our coatings have proven resistance to mold growth (ASTM G21 – “zero growth”), offers improved slip resistance (ASTM C0128 – “>.60”), and is easy to clean and maintain.

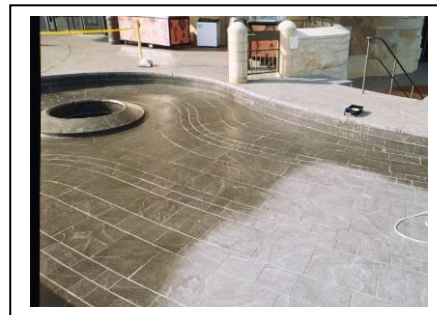
Cleaned – Coating Begins

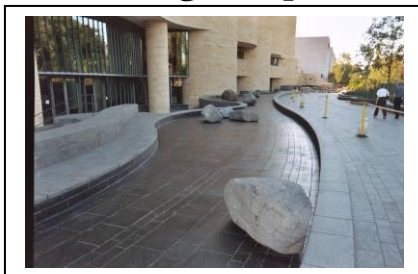
Coating Completed!

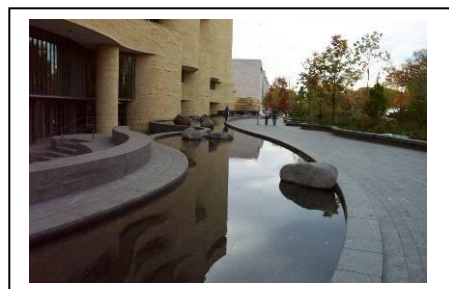
Fresh Water Restored
